City of Beacon, New York

DEVELOP AN IMPLEMENTATION
PLAN TO CONSOLIDATE BEACON'S
THREE FIREHOUSES

FINAL REPORT

October 2014

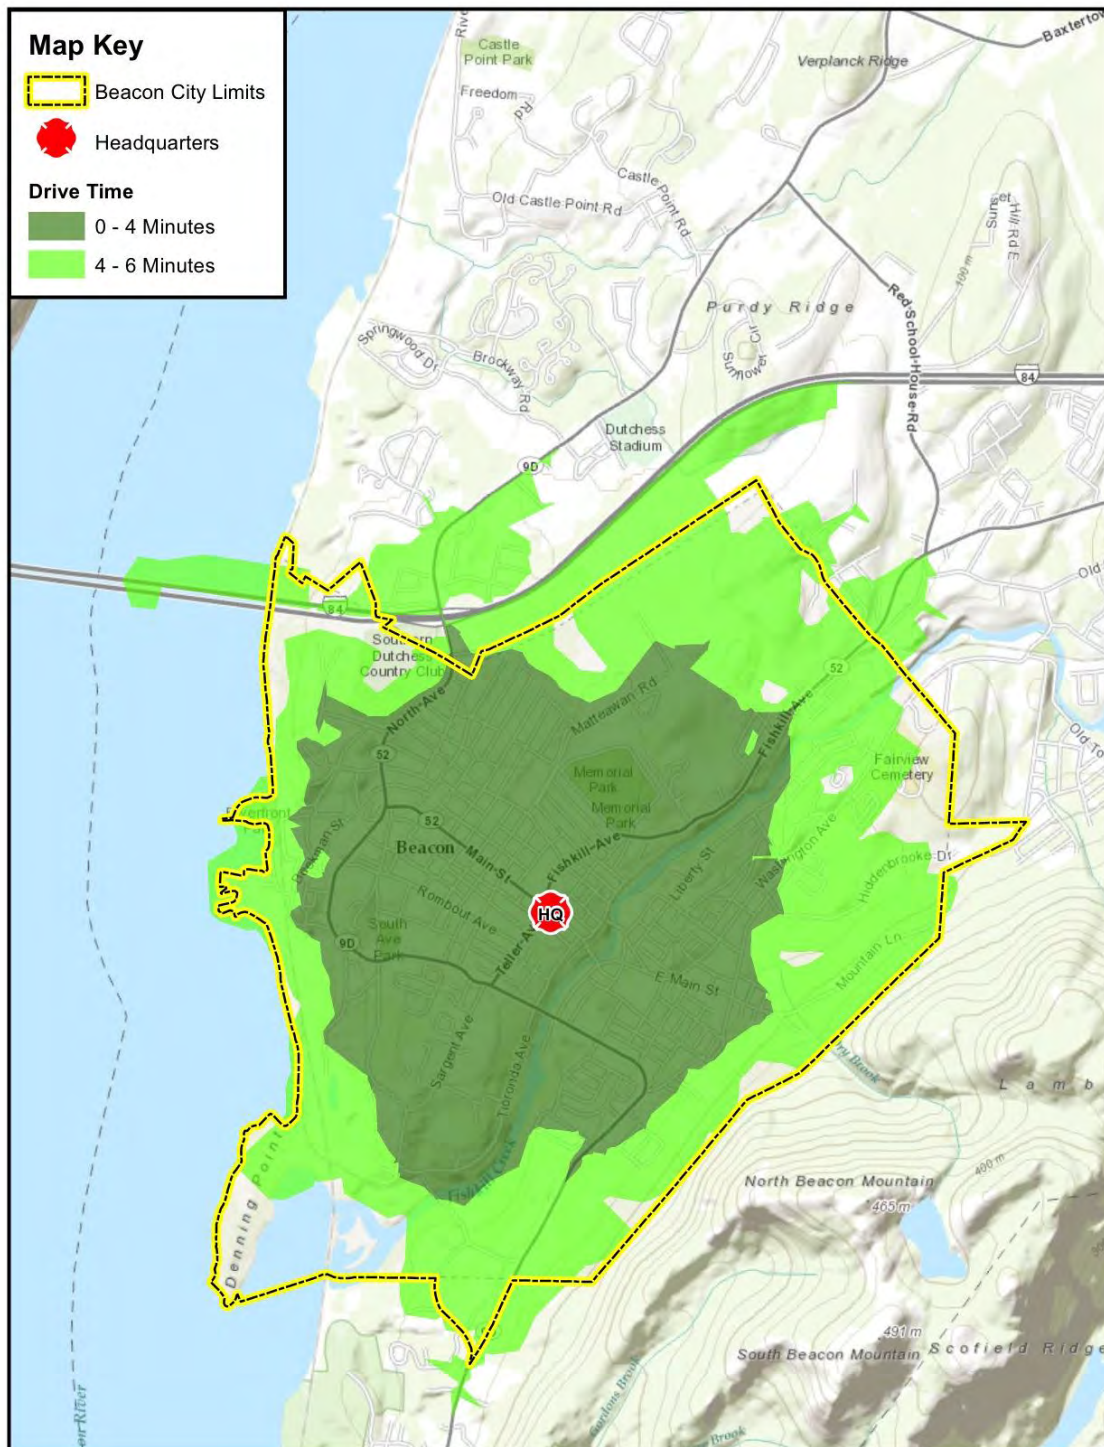
Figure 18: Drive Time from Mase Hook and Ladder Station (Headquarters)

The current Mase Hook and Ladder Station ("Headquarters") is better than any of the proposed locations from a response perspective, including the Cannon Street Practice Field site. Figure 18 shows the response time coverage from the Mase Hook and Ladder Station alone. This station provides nearly perfect 4-minute coverage to all areas of Beacon. However, this site is wholly unfeasible as a site for the construction of a new station. (See Appendix D for an explanation for TriData's performance measurement methodology.)

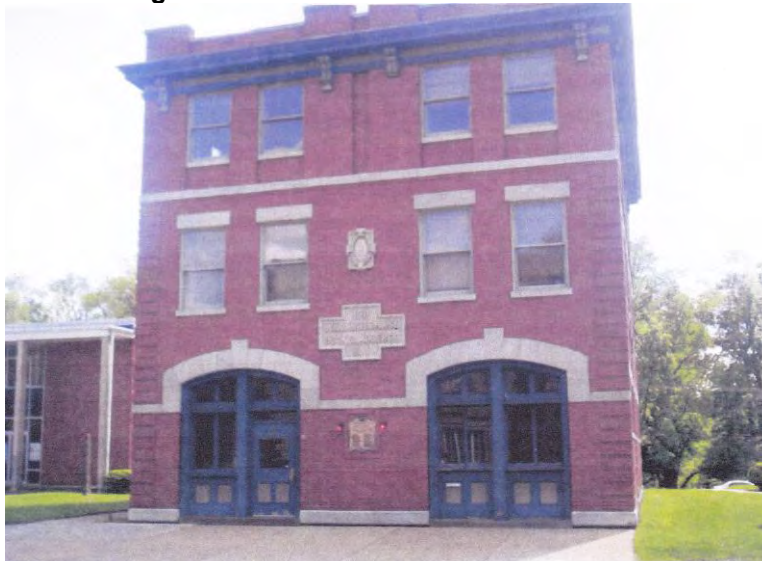
Figure 19: Mase Hook and Ladder Station

Mase Hook and Ladder Station (Headquarters) – This station is listed in BFD nomenclature as “Headquarters” but it has not served in this capacity in about 8 to 10 years. Built in 1911 the firehouse is over 100 years old and has plenty of character. It has undergone several renovations over the years and is in surprisingly good shape. It is however woefully outdated. It houses a platform ladder that just barely fits into a station originally designed for horse and buggy fire response. Living conditions for the career firefighters stationed there are generally antiquated and not user friendly. There is also an atmosphere in the station of “ours and theirs” which is predicated on the fact that it is a volunteer station and that career members are just there. There is no common feeling of ownership; it is not contentious, but it is there. The platform ladder unit—while the project team did not witness it respond—must certainly be unwieldy in pulling out and backing in to the station. We also believe that a platform ladder is a poor operational choice for the City of Beacon (more on this later in the report). In short, we believe that Mase Hook and Ladder Station has outlived its long-standing usefulness. There was some discussion with the city officials we spoke with about selling the building for commercial purposes, which would require a significant investment for such a venture. Interestingly, Mase Hook and Ladder Station is undoubtedly in the best location for emergency response to all segments of the city, it is however completely unfeasible as a site for a new centralized station.

Recommendation: Based on the age and condition of the above stations and in concert with the proposed station consolidation in the long term the City of Beacon should seriously consider selling at the very least Mase Hook and Ladder and Beacon Engine Stations. The city should also seriously consider selling its most valuable asset, the Lewis Tompkins Hose Station. The sale of all of these valuable properties can help to partially offset the cost of building a new single consolidated station in creating a more cost efficient and operationally sound fire/EMS emergency delivery system.

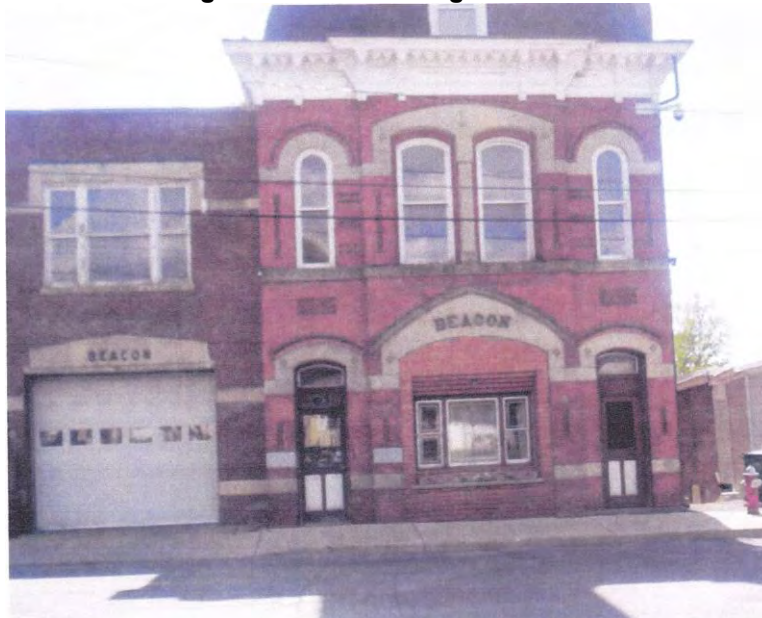
Figure 20: Beacon Engine Station

Beacon Engine Station (Station 1) – Beacon Engine is located on the west end of Main Street and the west side of the city. This station was built in 1889 and is 125 years old. It too has a great deal of character and old firehouse charm, but suffers from the same woeful out datedness as its counterpart Mase Hook and Ladder Station. In fact, overall it has many of the negative traits as Mase Hook and Ladder Station; poor living conditions; not user friendly; “our and theirs” atmosphere; tight quarters for the engine. Beacon Engine Station has also outlived its usefulness. There was also much discussion with the city officials about selling the building for commercial purposes. It too would require a significant investment for such a venture. Within the three station response model Beacon Engine Station is currently well placed, but is not a viable site for a new centralized station at all.

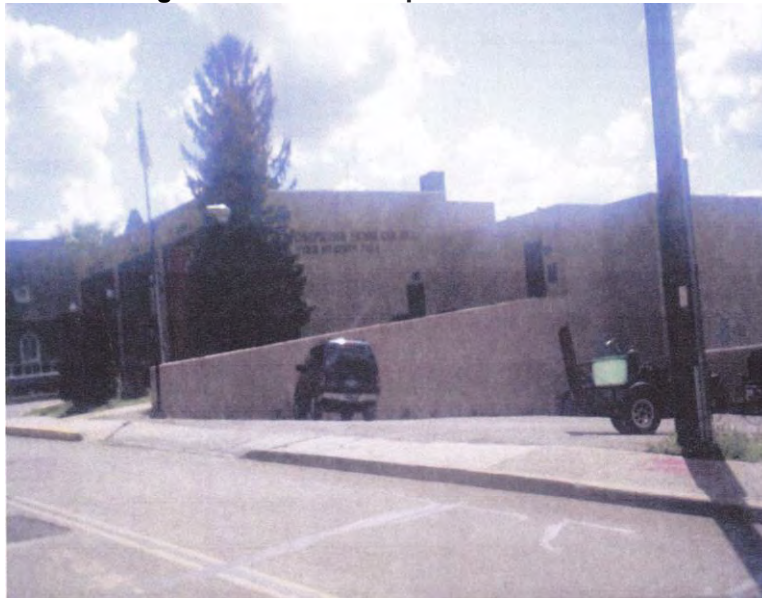
Figure 21: Lewis Tompkins Hose Station

Lewis Tompkins Hose Station (Station 2) – Lewis Tompkins Hose Station serves as the functional ad hoc headquarters for the BFD. The fire chief's office is there and most of the administrative functions on both sides of the combination department volunteer and career are conducted from this station. The structure is the most modern of the three stations and is in good condition. It has the best living conditions for firefighters out of the three station, but still is only fair and design poor in being user friendly. There is adequate room for the apparatus housed there. The station is well placed for the current three station response model but may not be in the most optimal location for a single centralized station response.
