# *Bridge Street Bridge*

*Beacon, New York*

## **A Historical Review, Existing Condition Report and Recommendations for Rehabilitation.**

**June 2018**

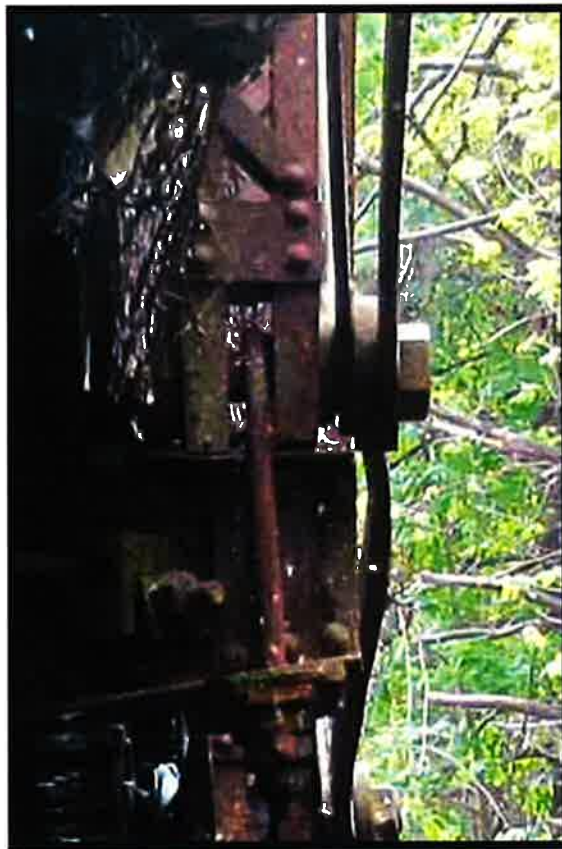
Bottom of posts setting on lower chord pins, and U-Bolts (note bent lower chord member)

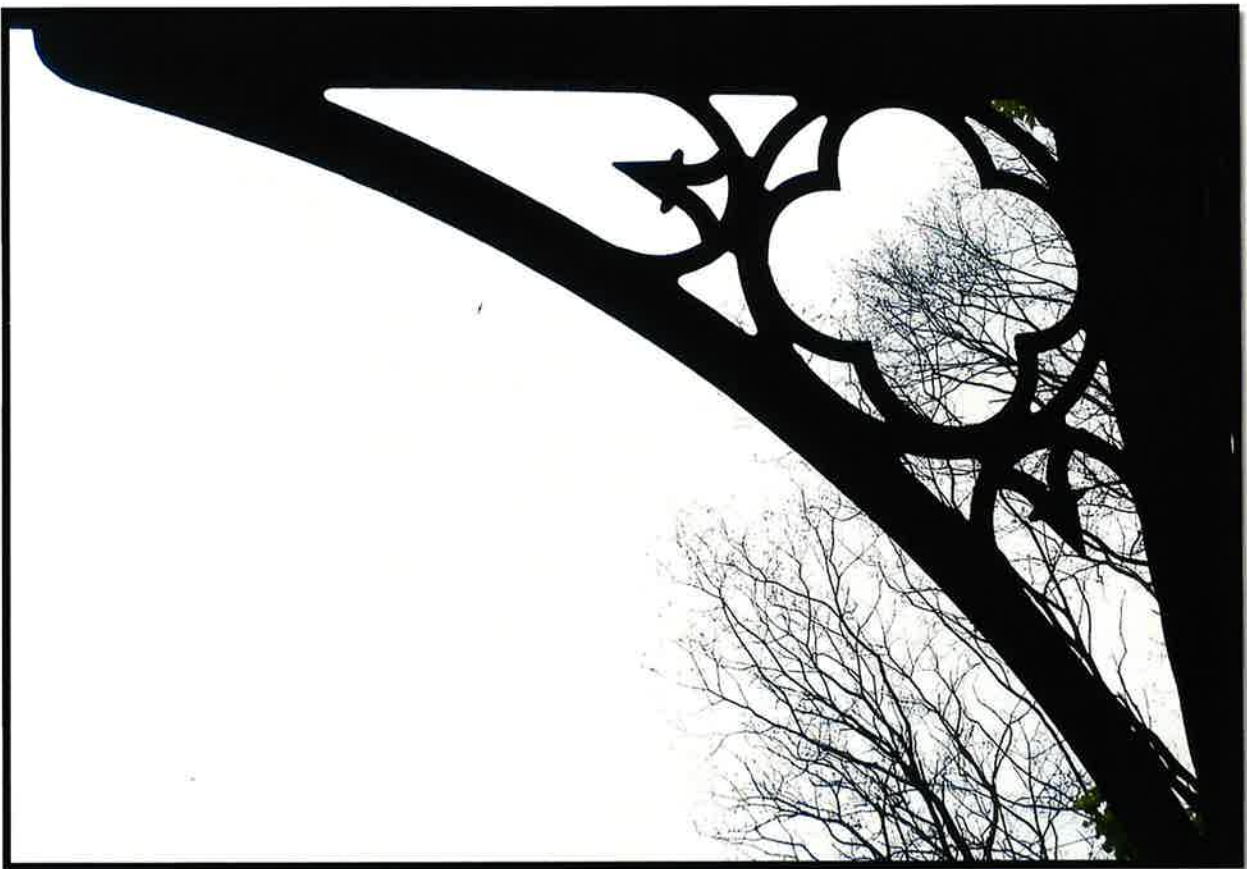
Cast Iron Tracery - Bolted to Cross Truss and Inclined End Post.

This bracing consists of a variable depth cross truss, built up with angles and double latticing. This cross truss also supports the bridge plaque. Cast iron tracery connects (bolts) to both the inclined end posts, on brackets riveted to the member, and the bottom flanges of the cross truss. In combination these elements keep the main trusses in a vertical position.

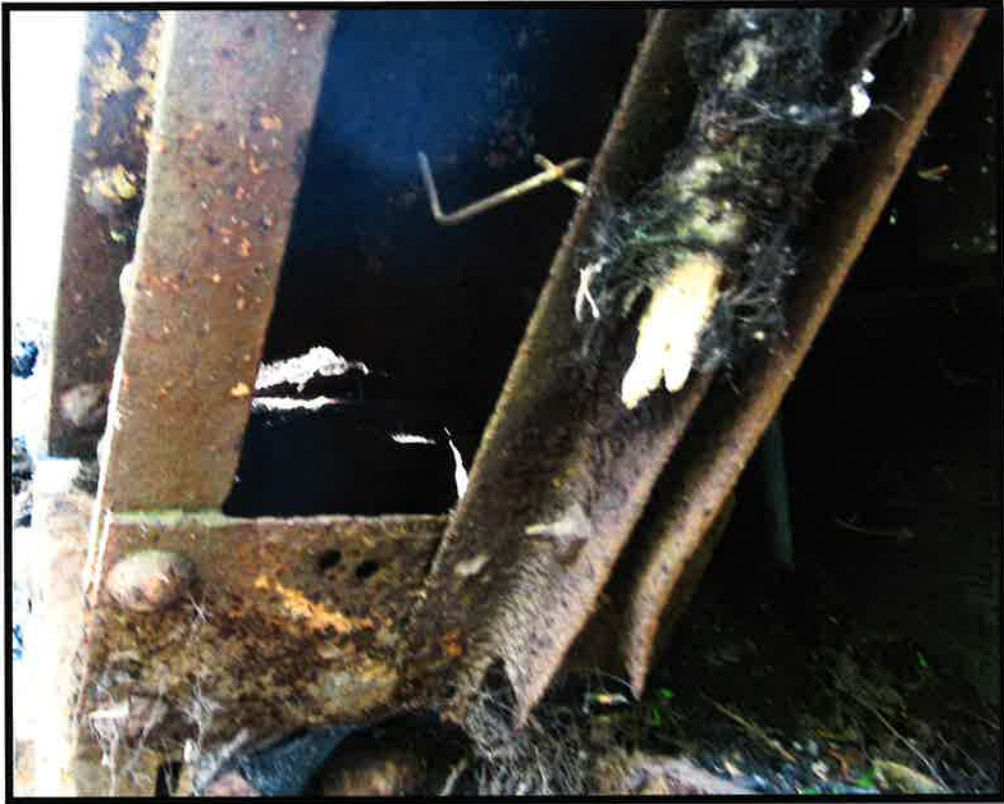
Southwest bridge seat under view (note poison ivy root system)  
Northwest Corner

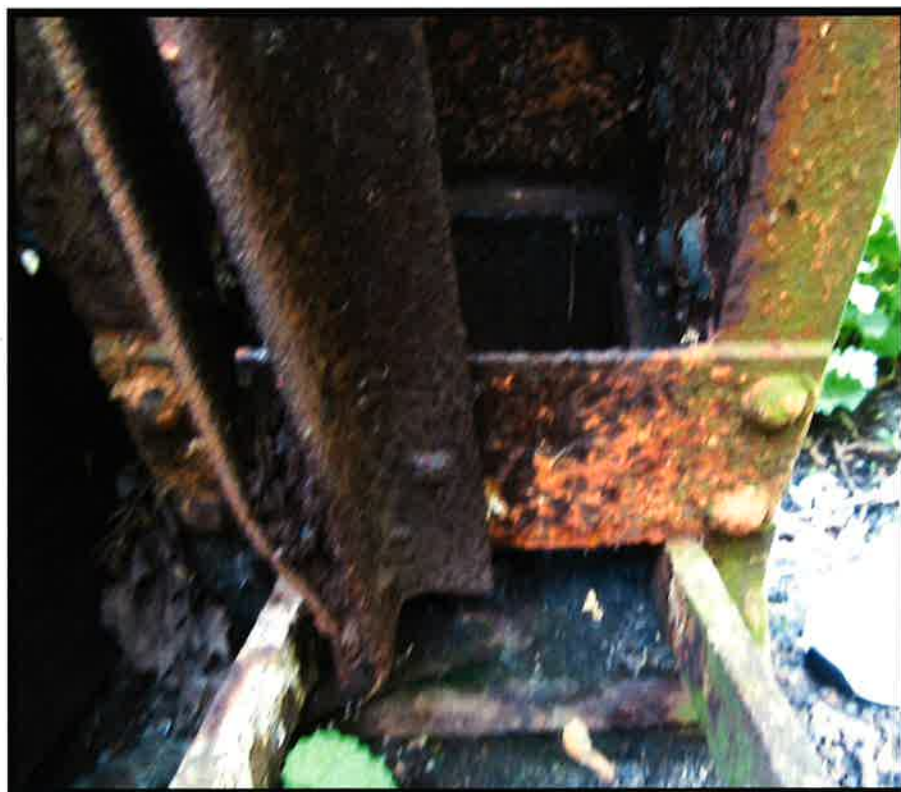
Image under northwest bridge shoe showing bearing surface on cast iron shoe, lower chord links. Note there is no additional bearing plate added to inside face of channels. Pin behind cross plate. Angle on bottom to receive hand railing

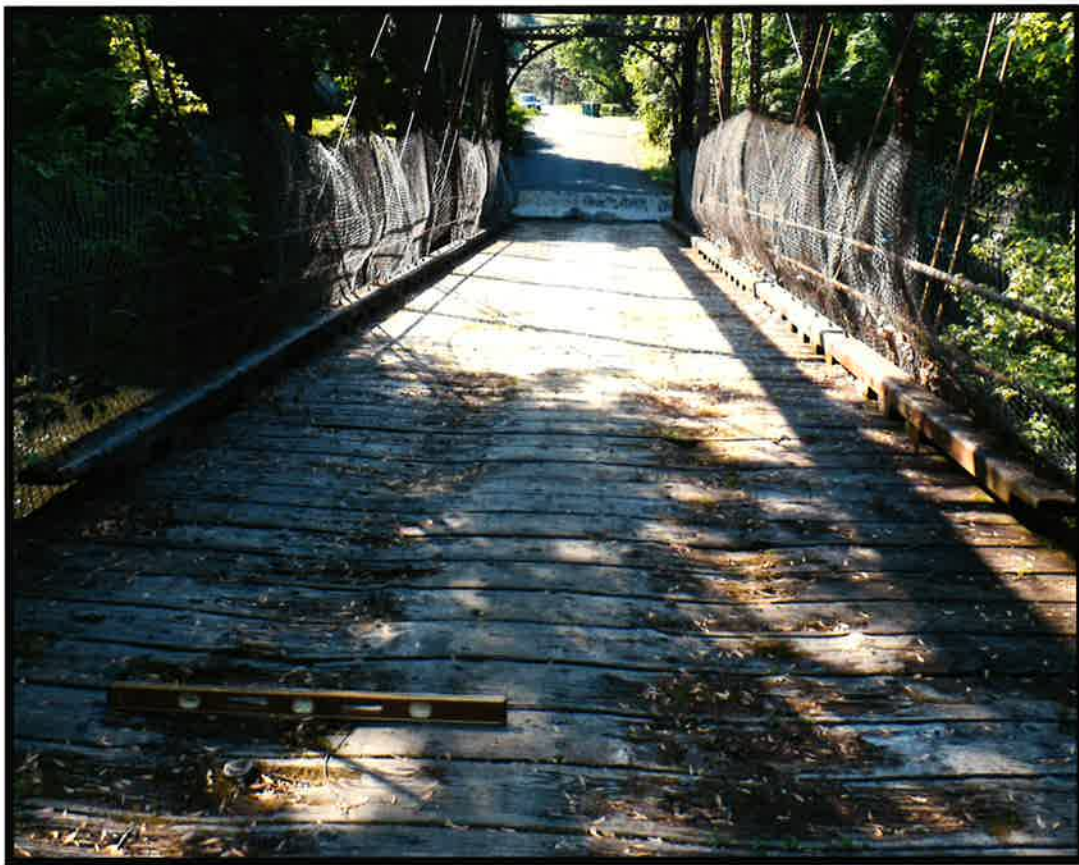
The decking is worn in two tracks and some members are rotting on the surface but generally the wood is sound and firmly attached to the stringers. The maximum depth of rut is approximately 1 1/2" with the edges of the planking and along the centerline at, or near, original elevation. The centerline of the southerly rut is about 6' in from the edge with the centerline of the northerly rut another 4+ feet to the north.

Deck with ruts, with some decay in the rut where water puddles. Depth of rut ~1 1/2".

1. Pressure wash decking removing any material between the deck planks as well as any decayed wood on the planks. Drill holes in each plank at the low spot of the ruts to permit drainage.

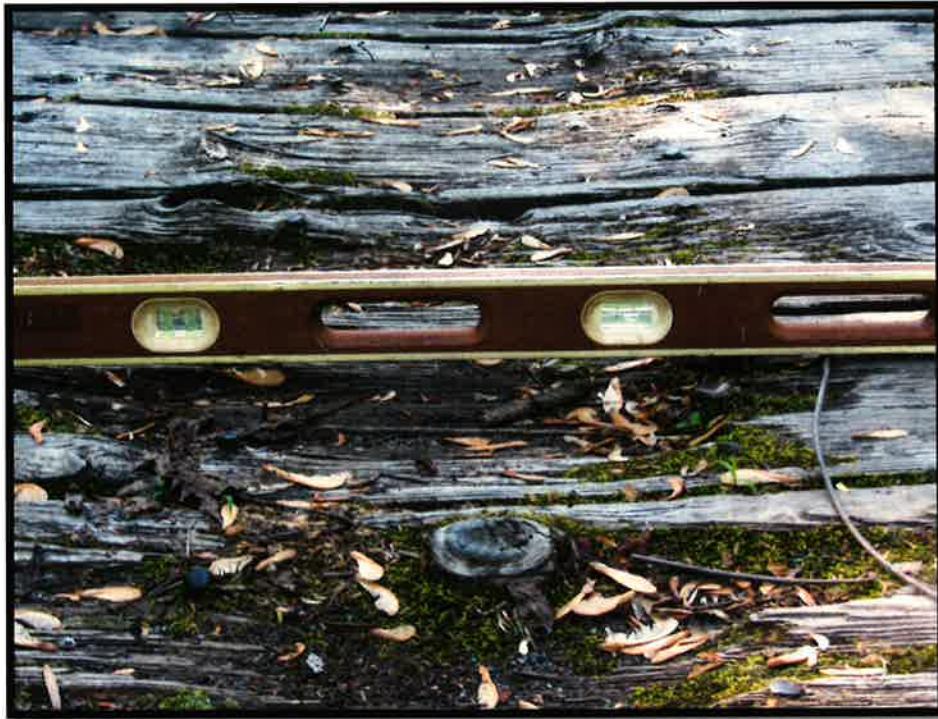
Rut on northerly side of centerline of the bridge showing ~1 ½" depression.

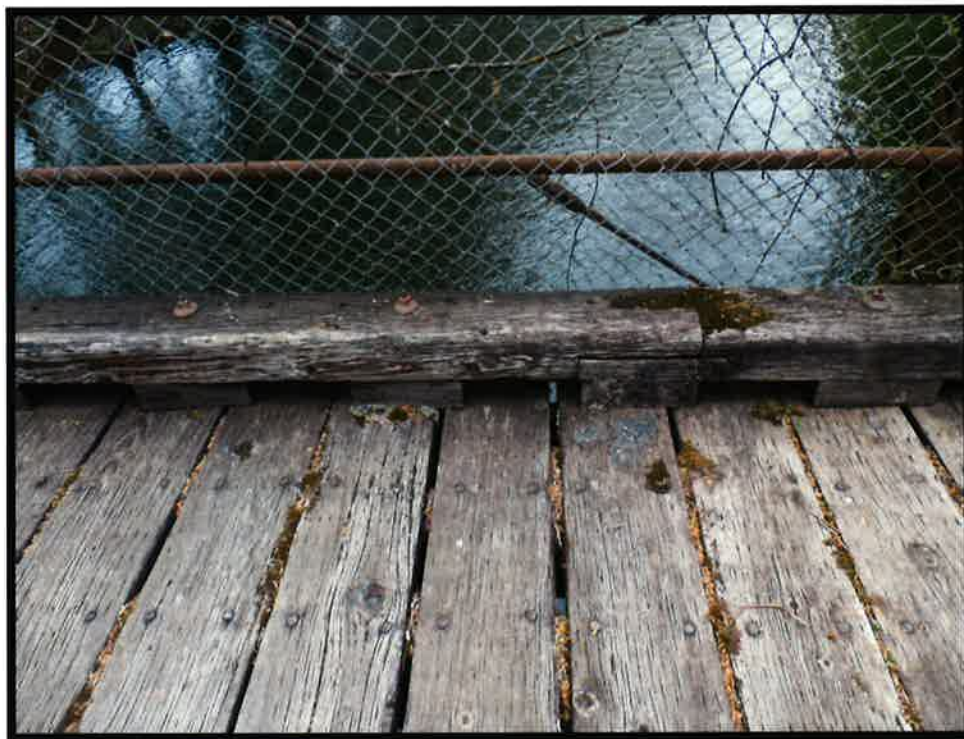
Wooden decking, curb and pipe railing, diagonal, note little decay along edges of decking. Note also organic material collecting in joints. It will be noted later on that this material should be power washed away to minimize further decay in the joint.

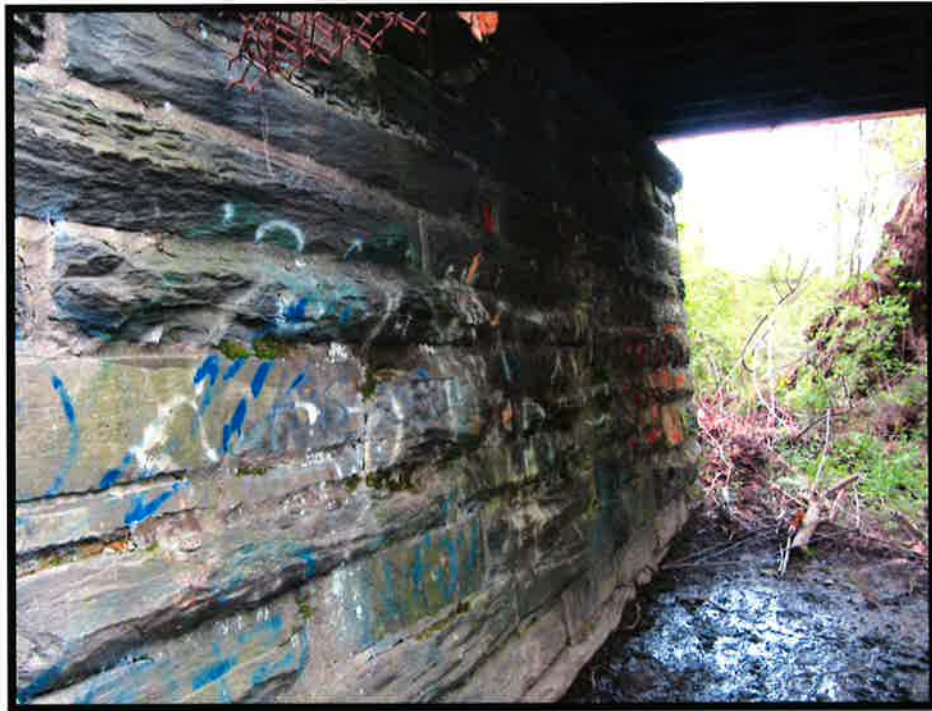
Face of west abutment showing pointed stonework

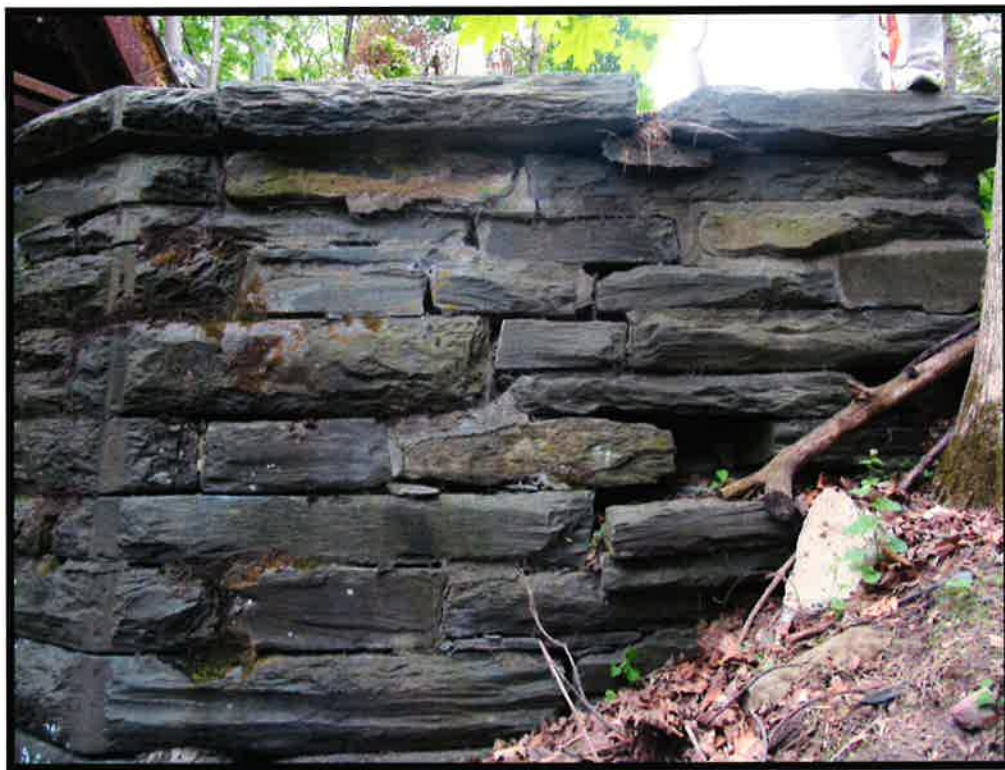
Southerly wing wall, tree should be removed as it is displacing the stonework and stone pushed back to original position

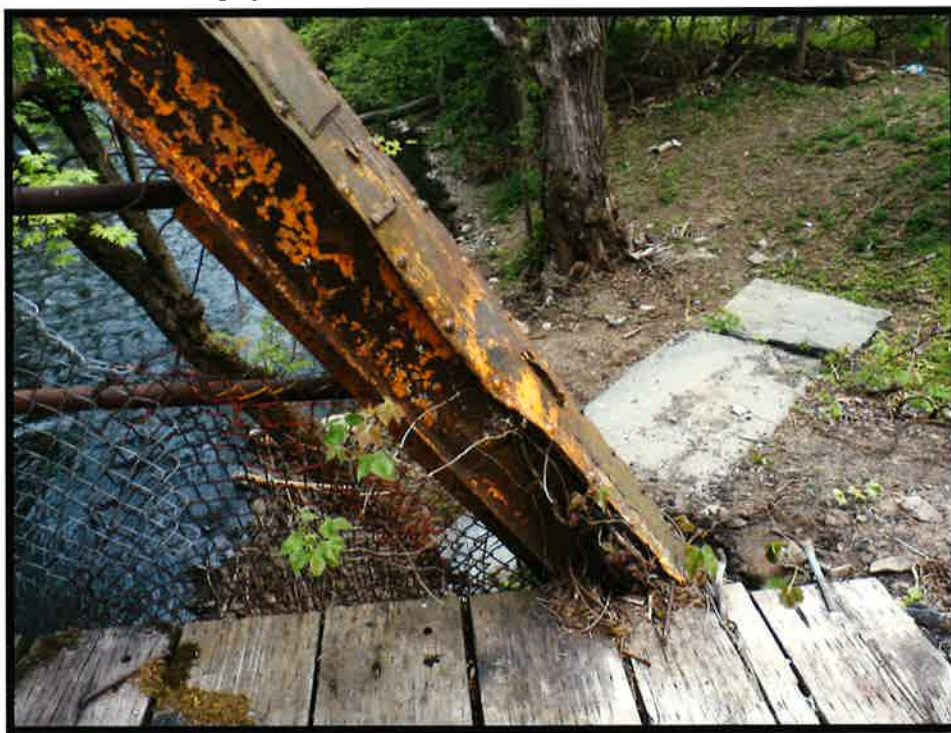
Next, I made observations of each bridge element between connections. The only problems observed were at the bridge seats and inclined end post area at each corner of the bridge. At the southwest end of the bridge the inclined end post had been hit by a motor vehicle in the past. This impact not only deformed the inside channel of the member but shifted the member on the cast iron shoe such that the channels do not have full bearing on the shoe. This impact also shifted the bridge joint L7 and twisted to a small degree the end of the cross beam.

Damaged inclined end post, southwest corner of bridge. Also previously welded plate at top end of image. Some yellow lead paint remains. The lower ~8' of the inclined end posts were painted yellow for visibility purposes

2. At the lower ends of the northwest, northeast and southeast inclined end posts weld 8" x 32" x 1/4" mild steel plates to span the corroded portions. (I would suggest a 3/32" - 7018 electrode.) On the southwest inclined end post weld an 8" x 32" x 1/2" plate to add bearing area to replace the bearing area on the lower flange of the channels. Weld new under lattice plate at the southeast bridge seat. Remove angle iron on the top chord of the northeast and southeast ends of the trusses.

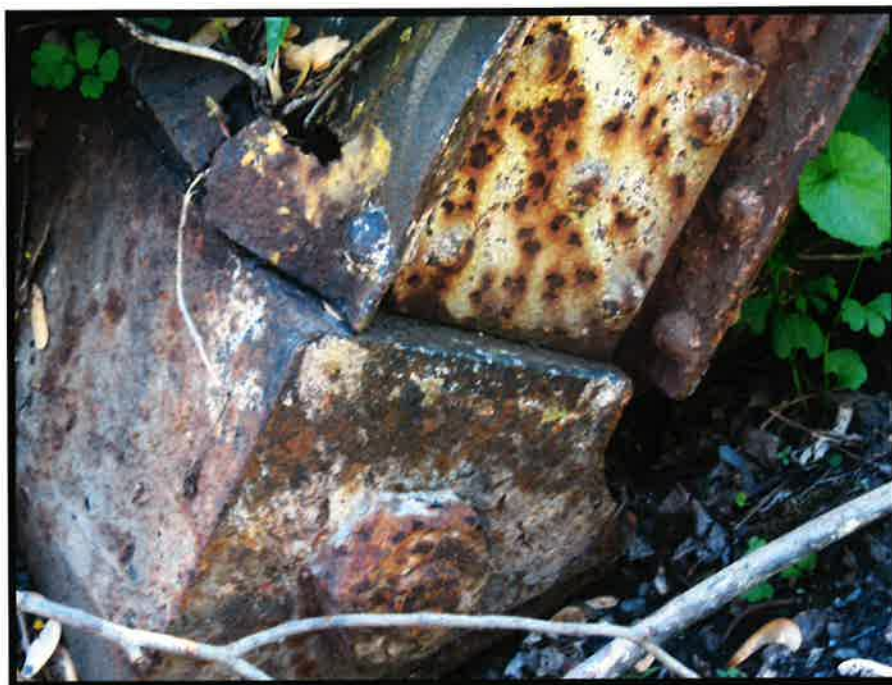
End post shifted on cast iron shoe resulting in less than full bearing. Note web plate riveted on web of channel to increase bearing still has full bearing. Member was not deflected transversely, only longitudinally.

On the other three inclined posts, where they connect with cast iron shoes, the top plate of the member had partly corroded through as can be seen above. This corrosion is mainly cosmetic and does not greatly impact the load carrying capacity of the inclined end chords, as the top plate's primary function is to maintain the orientation and separation of the two channels. One quarter inch  $\frac{1}{4}$ " cover plates should, however be welded on the existing top flange plates as described below. The angle iron on the northeast and southeast inclined end post should be removed in order to place new cover plates. On the southwest end the plate should be  $\frac{1}{2}$ " thick and in direct contact with the cast iron bridge shoe to make up for some of the bearing area lost on the lower flange of the channels.
