A. Existing Facility Inventory

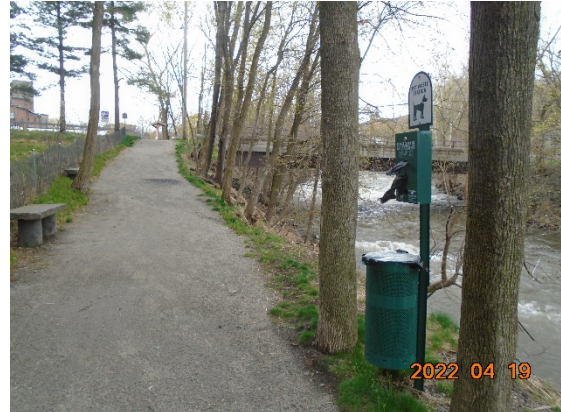
Fishkill Creek Greenway & Heritage Trail

- Paths & Walkways – Comprised primarily of crushed stone, trail is in good condition. Minor ADA compliance issues at street crossings, several of which are already planned for improvement in the near future.
- Site Amenities – Benches and “Dogipot” stations are located at frequent intervals along completed portions of the trail and are in generally good condition.
- Signage – Kiosk trailhead located at street crossings are in good condition, some graffiti on board. There is limited wayfinding or identification signage for the trail.
- Lawn / Greenspace – Lawn was in generally good condition along completed portions of the trail.
- Trees / Vegetation – Trees, shrubs, and vegetation along the trail were in good condition.

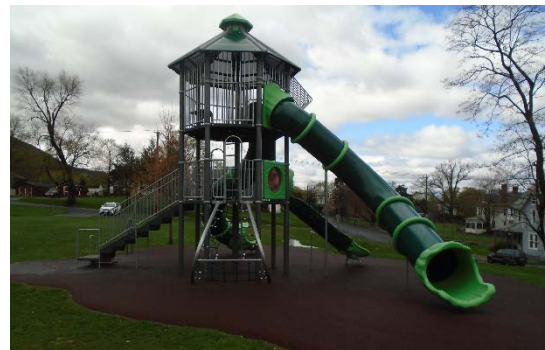
Green Street Park

- Basketball Court – Pavement cracks were observed in the court surfacing, with extensive patchwork repairs visible. Color surfacing and striping is worn and faded.

- Playground – Playground was recently installed and is in good condition. Signage is present and poured-in-place safety surfacing appears to be in good condition.

- Pavilion – Shade pavilion is in good condition. Minor graffiti was observed on the structure. The concrete pad was in good condition, very minor stormwater ponding observed.

- Site Amenities – Tables and waste bins beneath the pavilion were in good condition.
- Ball Game Pole – Structure is in fair condition, minor wear observed.

- Restroom Facility – Restroom structure was in fair condition. There is no ADA route to get to the restrooms, and while paint was in good condition a moderate amount of graffiti was present on the doors and CMU blocks.

- Parking Area – Asphalt of parking stalls was in good condition, quantity of stalls is limited. One stall is marked as ADA, however no signage was present.

- Signage – No park sign or wayfinding signage was present.
- Paths & Walkways – Path is comprised of stone dust with steel edging and is in good condition. Path appeared to be well maintained.

- Lawn / Greenspace – Turf was in good condition, very few bare spots observed. Ponding was observed in a depressed area at the corner of the park, currently used for stormwater detention area.

- Trees / Vegetation – Trees were in good condition, but very few located within park area resulting in limited shade.

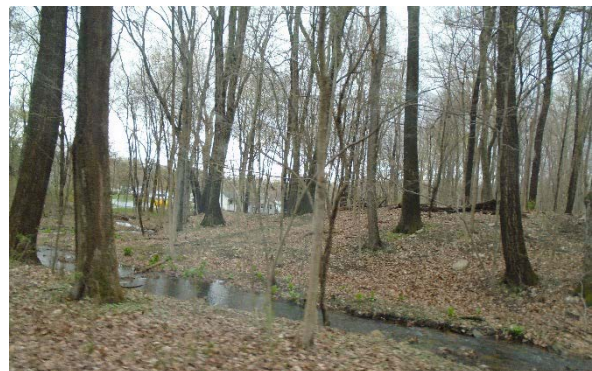
Hiddenbrooke Park

- Hiking Trails – Trails appeared to be in good condition and used frequently by surrounding neighborhoods.
- Parking Area – Gravel pull-off area is small in size, not adequate for use of park, and in fair condition. The driveway is paved throughout the park and is in good condition.
- Signage – Signage at the front of the park is embedded in stone pillars. They are in good condition, but difficult to read from a distance.

- Lawn / Greenspace – Meadow / lawn areas at the front of the site near the entry drive are in good condition, natural condition.
- Trees / Vegetation – Park is generally a natural area, trees appeared to be in good condition. Deadwood or trees in decline should be removed as necessary, especially around trail areas.

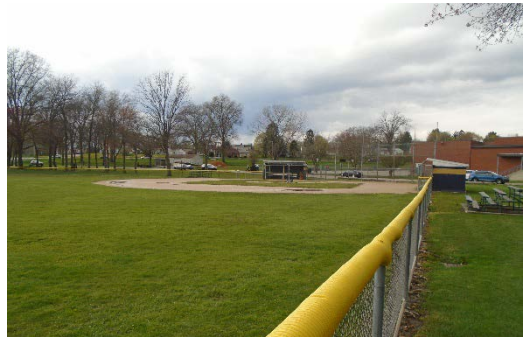
Memorial Park

- Soccer Field – Like elsewhere in the park, the field turf is in fair condition however contains numerous ponding areas and heavily saturated soils.
- Basketball Courts – The basketball courts are in poor condition with extensive drainage issues. The court area itself is situated below grade with a concrete curb as at one point it doubled as an ice rink during winter months. While the ice skating aspect of the court

is no longer utilized, the curb prevents runoff from escaping the court area resulting in ponding in excess of 3" after rain events.

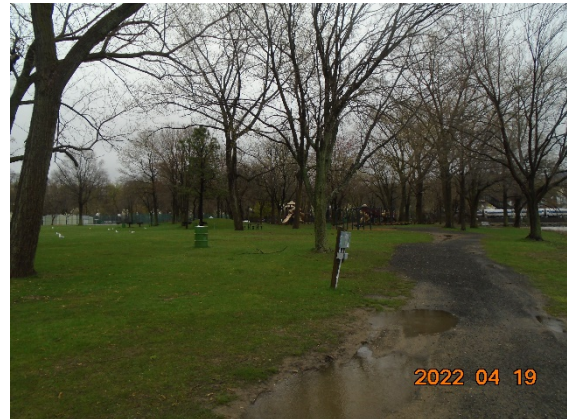
Pete & Toshi Seeger Riverfront Park

- Basketball Courts – The park contains one full and two half size basketball courts. All courts contain extensive pavement cracking, settlement, and patching. The fencing is in poor condition with several gaps and tears in the chain fabric. The court markings are faded, and the backboards have minor graffiti.

- Paths & Walkways – Paved walkways were in poor condition with extensive heaving and cracking evident, caused by the adjacent trees being too large and planted too close to the edge of walk. The gravel trail around the park perimeter was in fair condition, with some rutting and washout observed in spots.

- Shoreline – The rip-rap shoreline armoring appeared to be in good condition and preventing erosion of the park shoreline.

- Storage Sheds – Storage sheds appeared to be in good condition. The fence around the shed area was in much better condition than that around the courts, and the gate was locked with a chain and lock.
- Signage – Information signage was in good condition, however there was limited wayfinding signage to get to the park.
- Lawn / Greenspace – Turf was in good condition, especially in the interior of the park. Appeared to be well draining, some small bare spots were observed near the parking lot.
- Trees / Vegetation – Trees were in generally good condition, some are located too close to the parking area and paved walkways causing damage to the pavement.

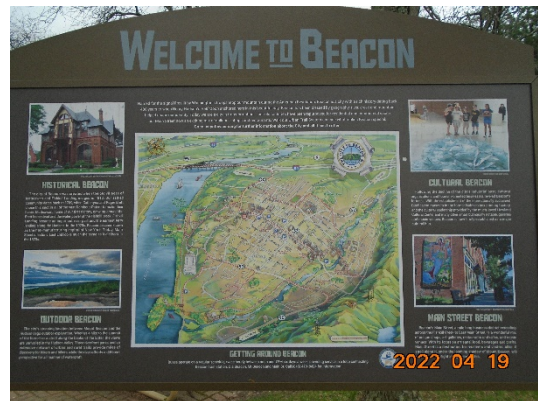
Polhill Park

- Bus Stop Shelter – Appeared to be in good condition, conveniently located to provide public transportation from the Visitor Center.
- Paths & Walkways – Plaza space appeared to be in fair condition, some weeds & moss growing within the pavers. The path to the visitor center was made of staggered steppingstones and did not appear to be ADA compliant.

- Signage – Historic marker and welcome sign appeared to be in good condition.
- Pop-Up Library – The wood structure of the pop-up library appeared to be in fair condition. The door hinge was not flush with the unit. Appeared to be well stocked with books.

- Lawn / Greenspace – Turf appeared to be in fair condition, some bare spots were evident around the paver area.

- Trees / Vegetation – Trees were generally in good condition and provided adequate shade over the area. The large evergreen tree is used for holiday displays in the winter.

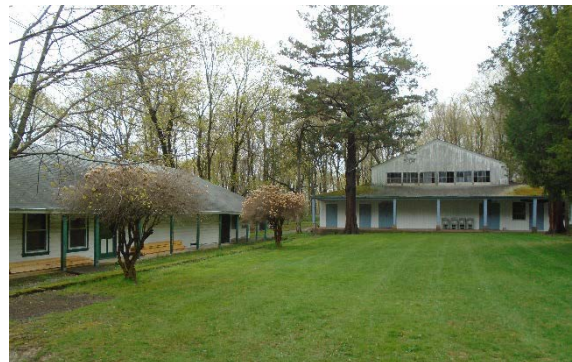
Settlement Camp

- Pool Facility – A fiberglass lined pool, the filter building and equipment was upgraded when the property was leased by the City. It is currently permitted by DOH (with some items grandfathered in) and operated during the summer months. The pool appeared to be in fair condition and has a unique configuration as the pool deck slopes around it, resulting in a retaining-wall like effect at the one end of the pool.

- Summer Camp Buildings – Approximately 5 of the structures in the park located along the main loop road are used for summer camp activities by the City during the summer. The buildings are in generally fair condition with some loose boards, clutter, broken windows, etc. Intent is to provide a wilderness experience within City limits for kids.

- Misc. Structures – Other buildings in the property are diffuse, spread out, and in very poor condition. City currently has no plans to renovate or restore these buildings as they are in too poor condition and too spread out to be adequately used for City events.

- Parking Area – Parking is inadequate to accommodate peak summer traffic and event crowds. The roads and parking areas are comprised of dirt and/or gravel, with no paved access roads.
- Signage – There is limited signage on site, very few wayfinding signs within the park or leading to the park.
- Lawn / Greenspace – The lawn areas were in good condition, very few bare spots observed.
- Trees / Vegetation – The park is primarily a natural area, trees appeared to be in good condition.
