Existing Facilities Inventory

City of Beacon

A. Existing Facility Inventory

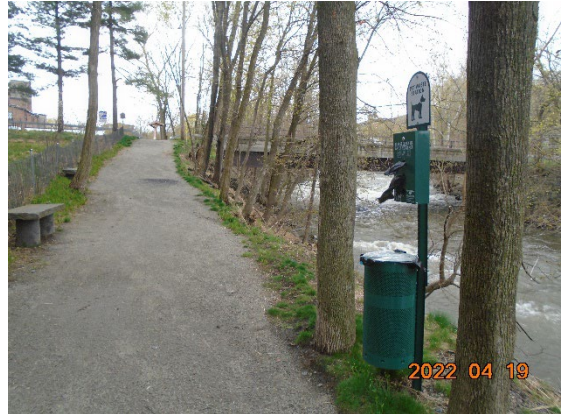
Fishkill Creek Greenway & Heritage Trail

- Paths & Walkways – Comprised primarily of crushed stone, trail is in good condition. Minor ADA compliance issues at street crossings, several of which are already planned for improvement in the near future.
- Site Amenities – Benches and “Dogipot” stations are located at frequent intervals along completed portions of the trail and are in generally good condition.
- Signage – Kiosk trailhead located at street crossings are in good condition, some graffiti on board. There is limited wayfinding or identification signage for the trail.
- Lawn / Greenspace – Lawn was in generally good condition along completed portions of the trail.
- Trees / Vegetation – Trees, shrubs, and vegetation along the trail were in good condition.

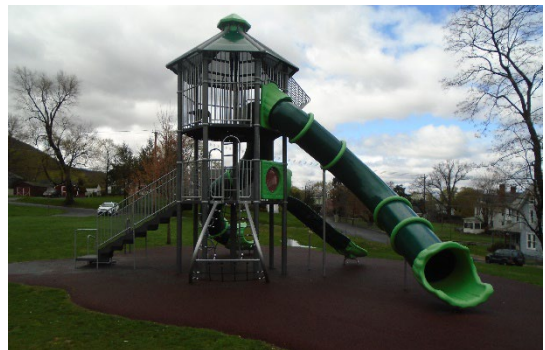
Green Street Park

- Basketball Court – Pavement cracks were observed in the court surfacing, with extensive patchwork repairs visible. Color surfacing and striping is worn and faded.
- Playground – Playground was recently installed and is in good condition. Signage is present and poured-in-place safety surfacing appears to be in good condition.

- Pavilion – Shade pavilion is in good condition. Minor graffiti was observed on the structure. The concrete pad was in good condition, very minor stormwater ponding observed.

- Site Amenities – Tables and waste bins beneath the pavilion were in good condition.
- Ball Game Pole – Structure is in fair condition, minor wear observed.

- Restroom Facility – Restroom structure was in fair condition. There is no ADA route to get to the restrooms, and while paint was in good condition a moderate amount of graffiti was present on the doors and CMU blocks.

- Parking Area – Asphalt of parking stalls was in good condition, quantity of stalls is limited. One stall is marked as ADA, however no signage was present.

- Signage – No park sign or wayfinding signage was present.
- Paths & Walkways – Path is comprised of stone dust with steel edging and is in good condition. Path appeared to be well maintained.

- Lawn / Greenspace – Turf was in good condition, very few bare spots observed. Ponding was observed in a depressed area at the corner of the park, currently used for stormwater detention area.

- Trees / Vegetation – Trees were in good condition, but very few located within park area resulting in limited shade.

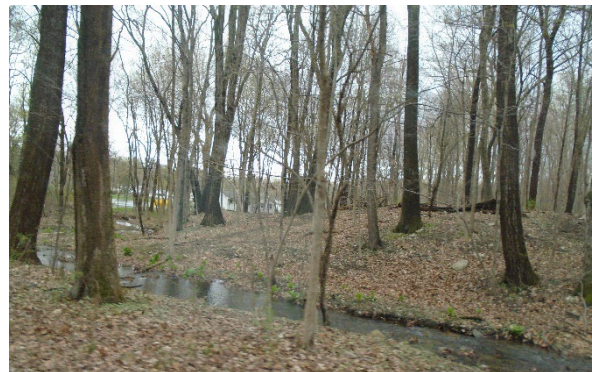
Hiddenbrooke Park

- Hiking Trails – Trails appeared to be in good condition and used frequently by surrounding neighborhoods.
- Parking Area – Gravel pull-off area is small in size, not adequate for use of park, and in fair condition. The driveway is paved throughout the park and is in good condition.
- Signage – Signage at the front of the park is embedded in stone pillars. They are in good condition, but difficult to read from a distance.
- Lawn / Greenspace – Meadow / lawn areas at the front of the site near the entry drive are in good condition, natural condition.

- Trees / Vegetation – Park is generally a natural area, trees appeared to be in good condition. Deadwood or trees in decline should be removed as necessary, especially around trail areas.

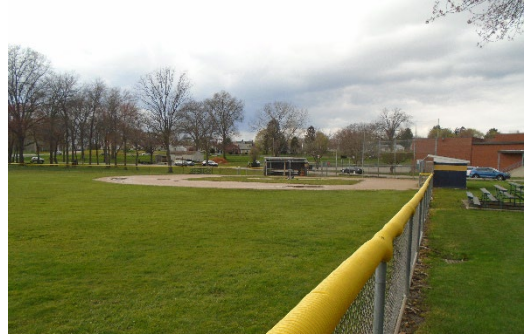
Memorial Park

- Football Fields – The football field is in fair condition with some minor drainage issues including poor drainage and ponding around the goal posts. The field has operational athletic lighting for evening activities, and a support building for the field is operated and maintained by the local Pop Warner football organization. The field is sometimes utilized for other sporting events, and no permanent striping is present.

- Baseball Fields – There is one full-size, two little league, and one tee-ball baseball fields located within the park. The fields are supported by the Joe Ferrone Memorial Fieldhouse, which contains storage and meeting spaces. The athletic lighting at the large field is currently inoperable. Fencing, backstops, and dugouts at all fields appeared to be in good condition, and the skinned infields were in fair condition with minor weeds and ponding. The outfields and perimeter areas appeared to be in fair condition, with moderate drainage issues ranging from soft soils to ponding. Scoreboards appeared to be in fair condition and the warning tracks were not uniformly installed and appeared to be in fair condition as well.

- Softball Fields – There are three full size and one youth softball fields located within the park. Athletic lighting is currently inoperable according to City staff. Fencing, backstops, and dugout benches at all fields appeared to be in good condition, and the skinned infields were in fair condition with minor weeds and ponding. The outfields and perimeter areas appeared to be in fair condition, with drainage issues ranging from soft soils to heavy ponding.

- Soccer Field – Like elsewhere in the park, the field turf is in fair condition however contains numerous ponding areas and heavily saturated soils.
- Basketball Courts – The basketball courts are in poor condition with extensive drainage issues. The court area itself is situated below grade with a concrete curb as at one point it doubled as an ice rink during winter months. While the ice skating aspect of the court is no longer utilized, the curb prevents runoff from escaping the court area resulting in ponding in excess of 3" after rain events.

- Tennis Court – The tennis courts are currently unusable and in very poor condition. The court pavement is deteriorated and perimeter fencing is disassembled in some areas. Netting is currently not installed and the court surface has settled in areas and accumulated debris.

- Skate Park – The skate park is located adjacent to the southern parking lot and located where two additional tennis courts used to be situated. The skate park is community managed, was recently resurfaced and appeared to be in good condition. Fencing was intact, minor ponding observed in some areas.

- Playground / Tot Lot – Future renovations are currently planned for the Tot Lot area. Safety surface was installed and appeared to be in fair condition, and the fencing was in good condition. Play equipment is a mix of permanent structures and movable toys, appearing to be in fair condition.

- Natural Play Area – The Wee Woods play area contains fallen logs, rope courses, and other outdoor-themed installations. It appeared to be in good condition.

- Pavilion – Pavilion structures appeared to be in good condition, minor graffiti was observed.
- Site Amenities – Many of the bleachers, tables, and benches appeared to be rusted through and in poor condition. Some were missing components (end caps from bleacher rows, etc.) and had minor graffiti.

- Storage Sheds – The storage sheds appeared to be in good condition. According to City Staff, they are currently too small to meet the needs of the park.

- Parking Areas – Striping within the parking areas is inconsistent and faded. There is a mix of off-road parking lots and nose-in parking directly off the side of Wilkes Street. The pavement appeared to be in fair condition, with some drainage and ponding issues evident, especially at the southern parking lot.

- Restroom Facility – The restroom facility appeared to be in good condition. A mural was recently painted on all sides of the structure as a collaborative effort between the community and a local artist, and no graffiti was visible on the structure.

- Lawn / Greenspace – The turf itself appeared to be in good condition with few bare spots, however there was extensive evidence of poor drainage, with some areas ponding over 3” of water.

- Trees / Vegetation – Trees within the park were in good condition.

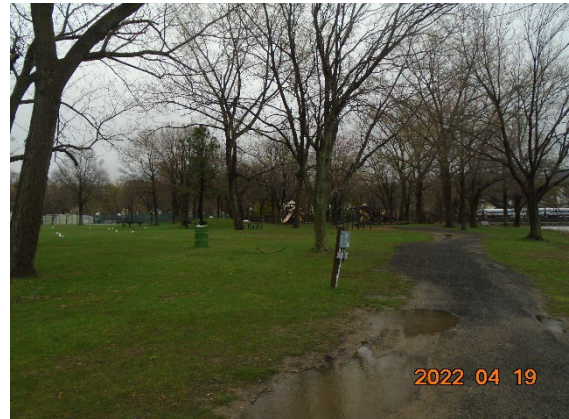
Pete & Toshi Seeger Riverfront Park

- Basketball Courts – The park contains one full and two half size basketball courts. All courts contain extensive pavement cracking, settlement, and patching. The fencing is in poor condition with several gaps and tears in the chain fabric. The court markings are faded, and the backboards have minor graffiti.

- Volleyball Courts – The sand volleyball courts are in fair condition. The netting appeared to be in good condition and well maintained, and the sand area itself has minor weeds and debris from adjacent trees within them. There is no defined edge to the sand area.

- Playground – The playground appeared to be in fair condition. Minor graffiti was observed on some play structures, and the safety surfacing lacks an adequate ADA transition from the adjacent walkways. Edging is provided in the form of varied height timber piles.

- Paths & Walkways – Paved walkways were in poor condition with extensive heaving and cracking evident, caused by the adjacent trees being too large and planted too close to the edge of walk. The gravel trail around the park perimeter was in fair condition, with some rutting and washout observed in spots.

- Parking Area – The parking area appeared to be in fair condition. Striping was worn and faded, and associated signage was crooked. Minor cracking was observed in the pavement.

- Site Amenities – Park grills were rusted through and in poor condition. Benches varied in material and size throughout the park; the benches along the perimeter trail were in good condition while others were generally poor. Tables located in the park interior were in similarly poor condition, and minor graffiti was evident on some pieces.

- Pavilion – The pavilion is in good condition. Concrete pad was in good condition with no cracking, and only minor graffiti was observed on the structure.

- Shoreline – The rip-rap shoreline armoring appeared to be in good condition and preventing erosion of the park shoreline.

- Storage Sheds – Storage sheds appeared to be in good condition. The fence around the shed area was in much better condition than that around the courts, and the gate was locked with a chain and lock.
- Signage – Information signage was in good condition, however there was limited wayfinding signage to get to the park.
- Lawn / Greenspace – Turf was in good condition, especially in the interior of the park. Appeared to be well draining, some small bare spots were observed near the parking lot.
- Trees / Vegetation – Trees were in generally good condition, some are located too close to the parking area and paved walkways causing damage to the pavement.

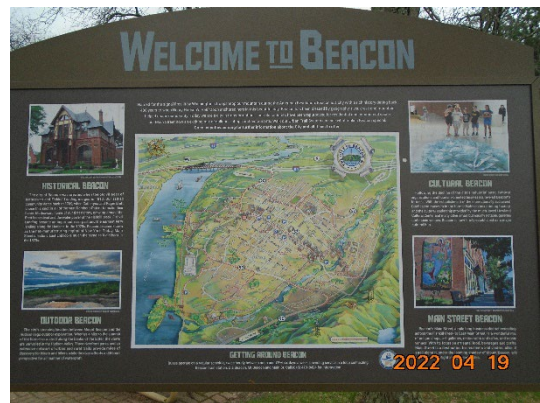
Polhill Park

- Visitor Center – Operated by the Chamber of Commerce, the building structure appeared to be in good condition. Would benefit from additional signage.

- Site Amenities – Tables and benches appeared to be in fair condition. There was a lack of consistent style & material across amenities – some were wood, some plastic, colors did not match, etc.

- Parking Area – There is no parking area designated for the park – the only available spaces were located at the adjacent Fire Department and were signed to prevent public parking. Only two spaces were available, each for 2-hour EV charging only, and there was one designated stall for Visitor Center employees.

- Bus Stop Shelter – Appeared to be in good condition, conveniently located to provide public transportation from the Visitor Center.
- Paths & Walkways – Plaza space appeared to be in fair condition, some weeds & moss growing within the pavers. The path to the visitor center was made of staggered steppingstones and did not appear to be ADA compliant.

- Signage – Historic marker and welcome sign appeared to be in good condition.
- Pop-Up Library – The wood structure of the pop-up library appeared to be in fair condition. The door hinge was not flush with the unit. Appeared to be well stocked with books.

- Lawn / Greenspace – Turf appeared to be in fair condition, some bare spots were evident around the paver area.

- Trees / Vegetation – Trees were generally in good condition and provided adequate shade over the area. The large evergreen tree is used for holiday displays in the winter.

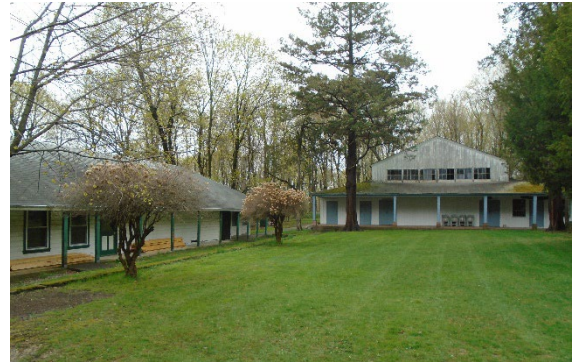
Settlement Camp Park

- Disc Golf – The disc golf course was constructed and is maintained by a volunteer group and occupies one of the buildings within the park. The building is in fair condition, appropriately signed, and the notice board and course elements appeared to be in fair condition as well.

- Pool Facility – A fiberglass lined pool, the filter building and equipment was upgraded when the property was leased by the City from New York State Parks. It is currently permitted by DOH (with some items grandfathered in) and operated during the summer months. The pool appeared to be in fair condition and has a unique configuration as the pool deck slopes around it, resulting in a retaining-wall like effect at the one end of the pool.

- Theater Building – Building is in good condition, currently used for drive-in movies organized by the City and rented out by the City to residents as a wedding venue. It is very popular and used frequently.

- Summer Camp Buildings – Approximately 5 of the structures in the park located along the main loop road are used for summer camp activities by the City during the summer. The buildings are in generally fair condition with some loose boards, clutter, broken windows, etc. Intent is to provide a wilderness experience within City limits for kids.

- Gym Building – The large barn is in fair condition and contains a rock climbing used by the Beacon Boulder Club as well as space for the local garden club.

- Misc. Structures – Other buildings in the property are diffuse, spread out, and in very poor condition. City currently has no plans to renovate or restore these buildings as they are in too poor condition and too spread out to be adequately used for City activities and events.

- Homestead Building – This building is in good condition and currently houses the Hudson River Sloop Clearwater, Inc. organizational offices. It is somewhat underutilized and contains a lot of empty rooms.

- Caretakers House- A two bedroom ranch house utilized by the resident caretaker. The house is in good condition with recent renovations including a roof and kitchen remodel.

- Parking Area – Parking is inadequate to accommodate peak summer traffic and event crowds. The roads and parking areas are comprised of dirt and/or gravel, with no paved access roads.

- Signage – There is limited signage on site, very few wayfinding signs within the park or leading to the park.
- Lawn / Greenspace – The lawn areas were in good condition, very few bare spots observed.

- Trees / Vegetation – The park is primarily a natural area, trees appeared to be in good condition.

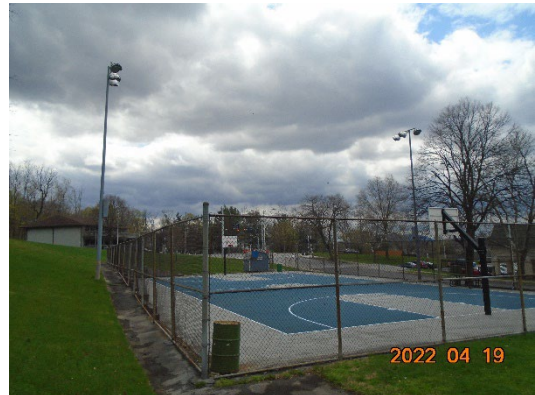
South Avenue Park

- Tennis Courts – Two tennis courts are located at the northwest corner of the park and are in fair condition. Net assemblies were in good condition; however, the court surfacing contains numerous cracks and the fencing around the court is in poor condition. The timber retaining wall supporting the courts is deteriorating, and there are currently plans to replace the wall soon.
- Basketball Court – The court surfacing is in good condition with minor cracking evident near the hoop assemblies. Minor graffiti was evident, fencing was in fair condition, and the court lighting appeared to be in good condition. As with the tennis court, the timber retaining wall is deteriorating and is planned for replacement.

- Horseshoe Court – Wood framing is deteriorating and there is extensive debris and weeds growing within the play area. Difficult to access and infrequently used according to City staff.

- Shuffleboard Court - Wood framing is deteriorating and there is extensive debris and weeds growing within the play area. Difficult to access and infrequently used according to City staff.

- Bocce Ball Court - Wood framing is deteriorating and there is extensive debris and weeds growing within the play area. Difficult to access and infrequently used according to City staff.

- Youth Employment Program Teaching Garden – Located outside of the Recreation Department, the garden is in good condition and well maintained.
- Multi-Use Open Field – Turf is in good condition, minor drainage issues evident.

- Multi-Use Paved Area – Large crack observed through center of pavement, pavement is in poor condition, extensive debris and weeds growing within the pavement area.

- Playground – Playground equipment and safety surfacing appeared to be in good condition. Some graffiti observed on play equipment, and there is no ADA accessible route to the playground.

- Parking Areas – Main parking area off South Avenue is in fair condition, striping is very faded and there is limited lighting. Pavement is in good condition. Parking at the Recreation Department Building is in good condition, used primarily by City staff.

- Signage – No signage in parking lot, one small sign to identify park located on light pole at South Avenue parking area.
- Pavilion – Located adjacent to the Recreation Department Building, pavilion appeared well maintained and in good condition.

- Paths & Walkways – Asphalt paths are in poor condition with moderate cracking and heaving present throughout the path system. Several areas appeared to be constructed on slopes that were not ADA compliant.

- Lawn / Greenspace – Turf was in good condition, very few bare spots observed. Some minor drainage issues were evident.
- Trees / Vegetation – Trees appeared to be in good condition, located throughout the park area.
